LEVEL 2

Your survey report

84 Airedale Road, Sheffield, South Yorkshire,
United Kingdom, S6 4AW

15/06/2022

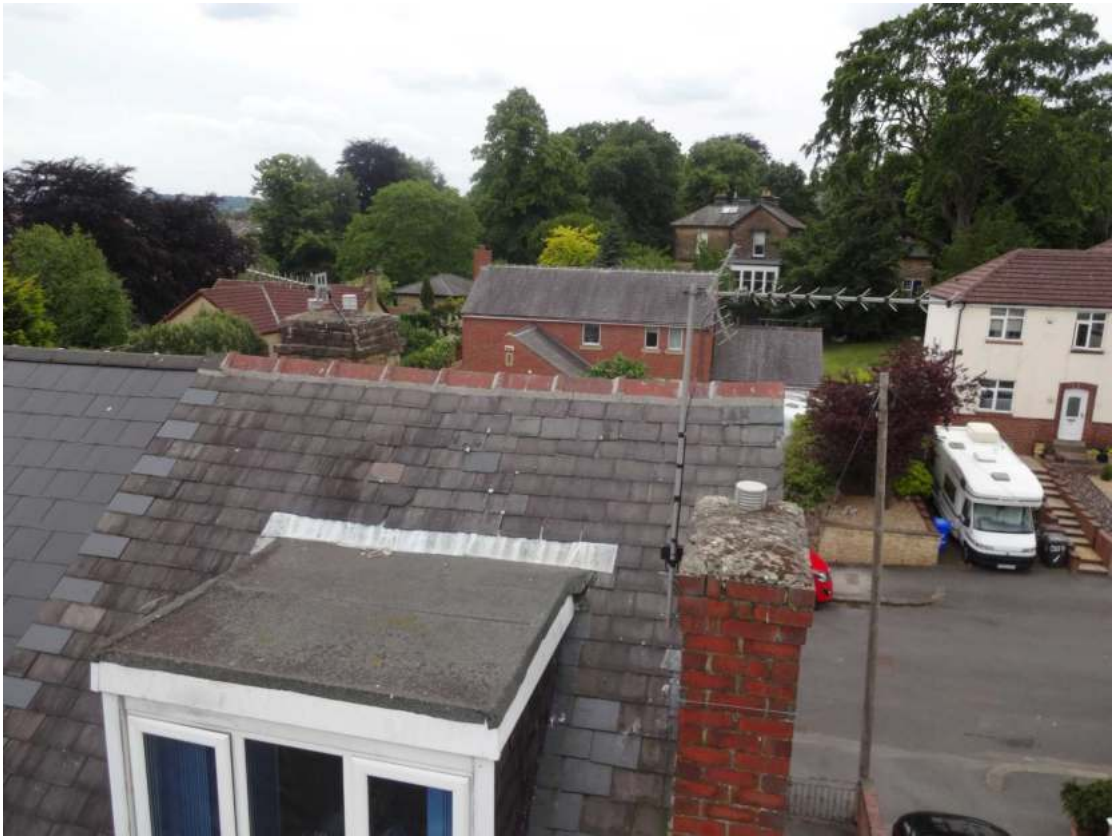
The condition of the sand cement flaunching around the top of the stacks however are slightly deteriorated, cracked and loose in areas. They would benefit from replacement of the flaunching.

Cracked flaunching around chimney terminals

Action: Budget for raking out and repointing stacks and replacement of the flaunching.

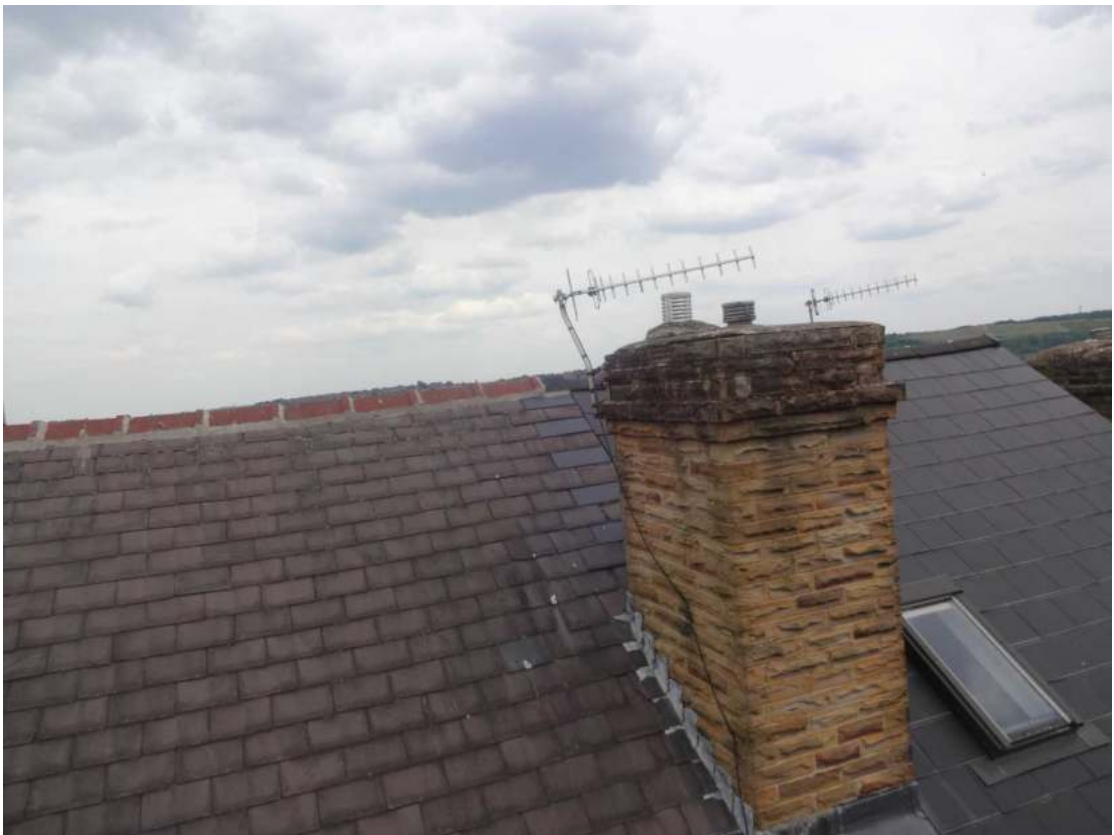
The pointing around the masonry at the top of the stack is also slightly defective in areas and would benefit from raking out and repointing in areas.

Cracked flaunching' around terminals and pointing

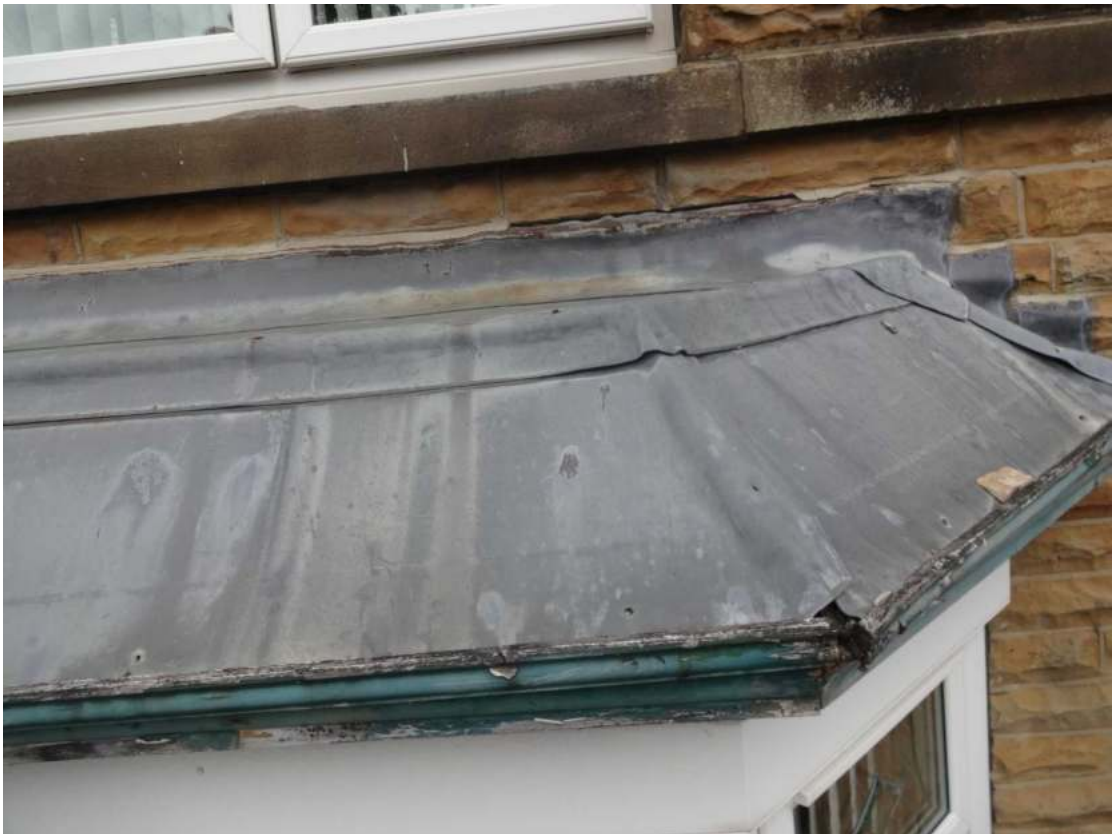
lead flashing loose to bay top

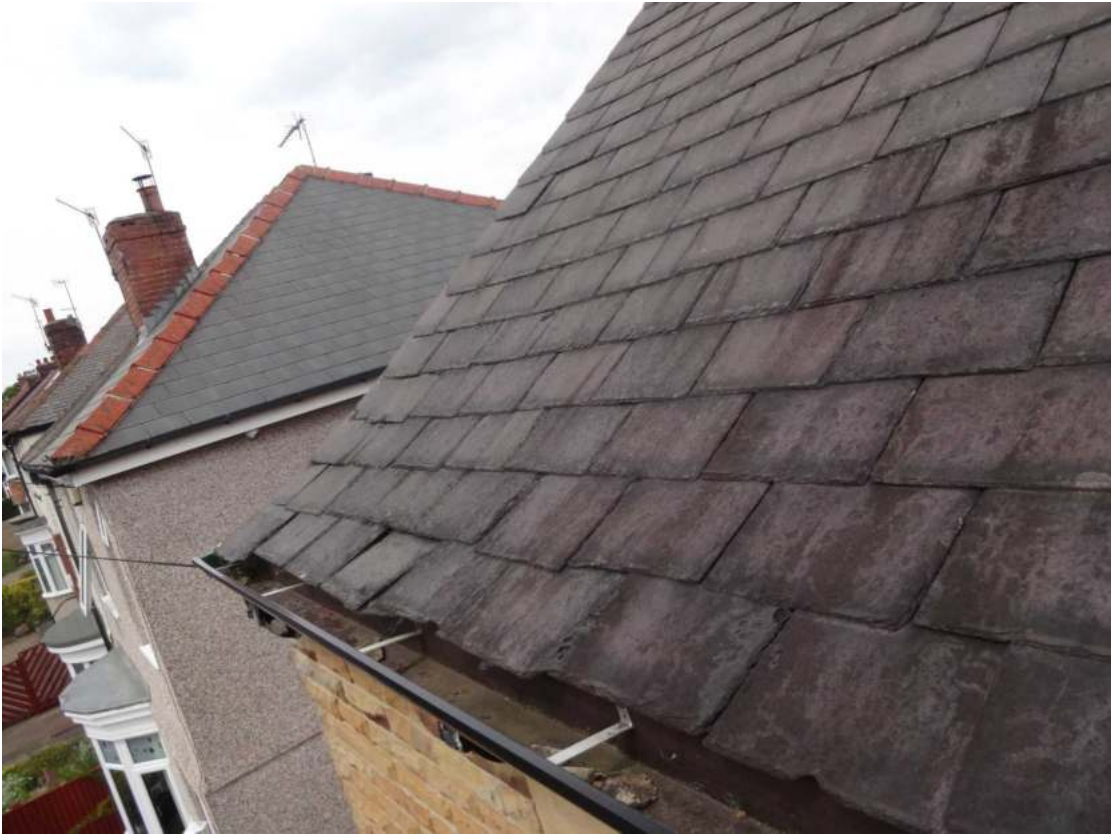
The condition of the roofs is generally deteriorated in numerous areas with the rear elevation being slightly worse than the front. There are numerous slipped, broken and missing slates. The lead linings to the valley abutments is deteriorated and has been sealed with bitumen in places indicating past leaks. The roofs require a thorough overhaul, replacing all broken and missing slates, removal and replacement of the lead lining to the valley and checking and numerous repairs throughout.

loose slates to roof

We would advise having the repairs to the roofs quoted against that of stripping the roofs and replacement with a new roof covering of a similar quality then a comparable decision can be made with all the costs to hand.

Action; Have a roofing contractor price for the repairs against that of a new roof.

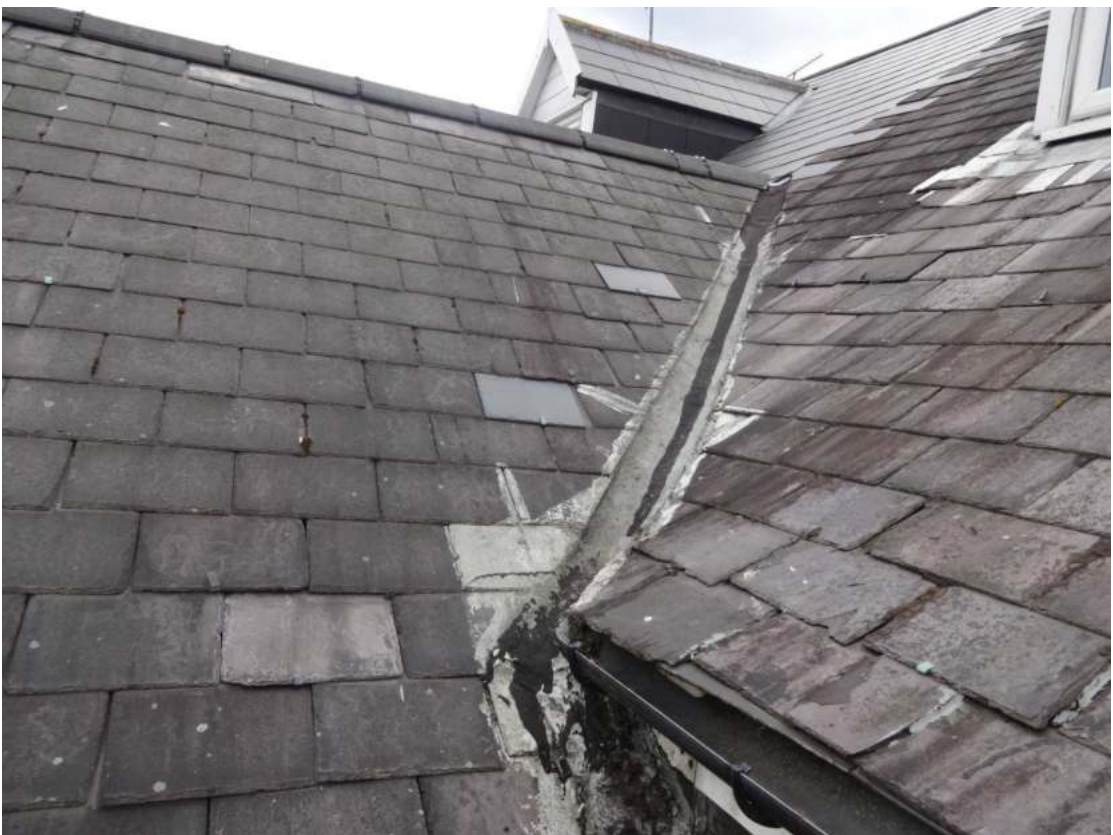
Valley gutter patch painted

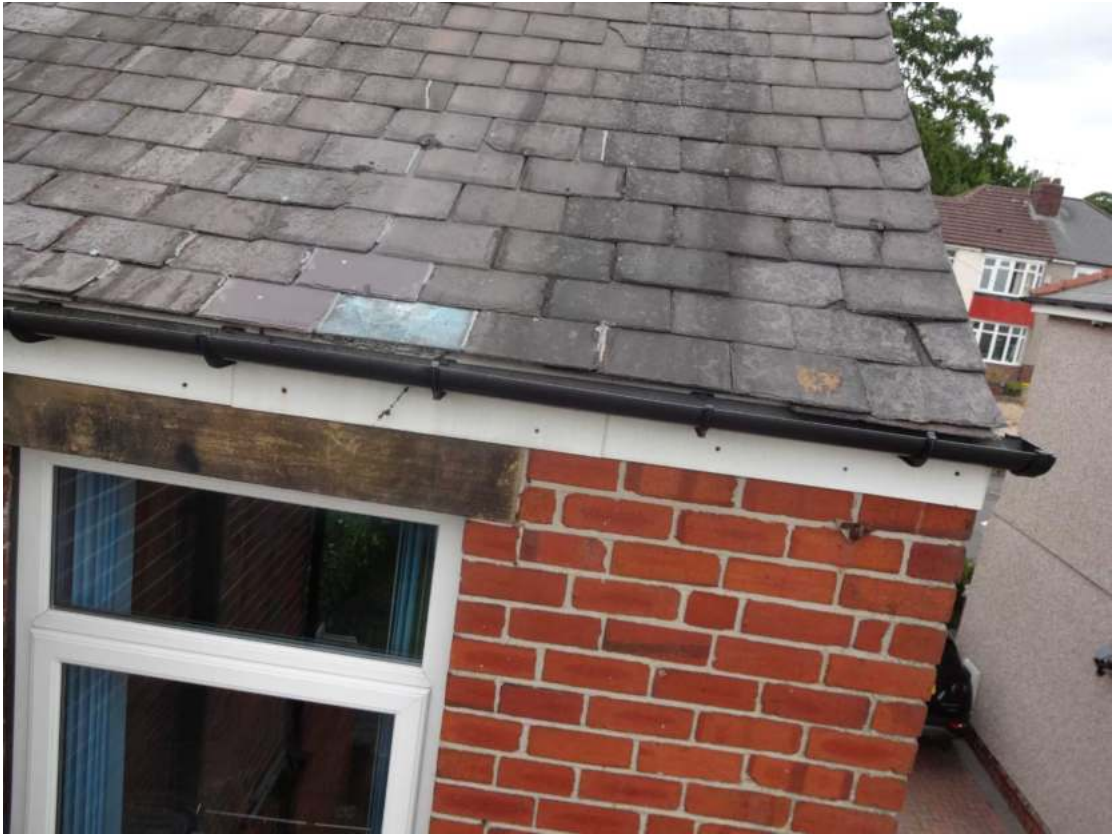
loose and damaged slates

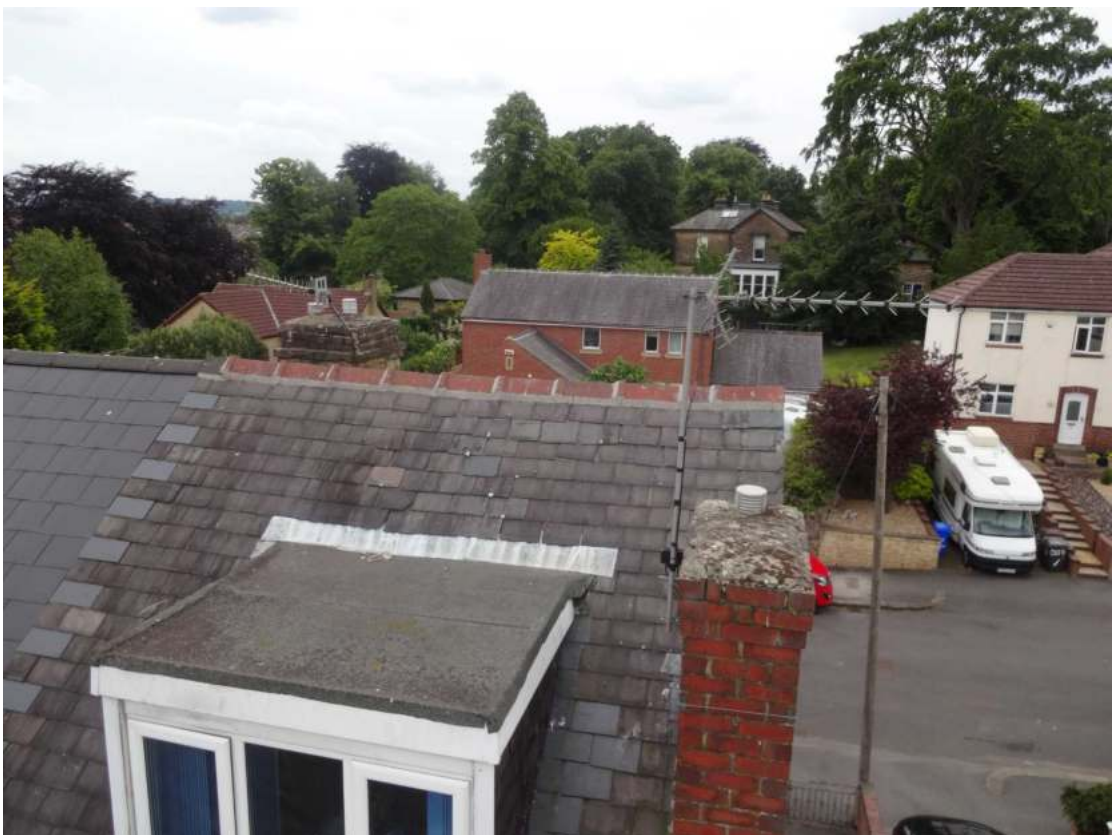
Dormer top covering is untidy and poorly fitted

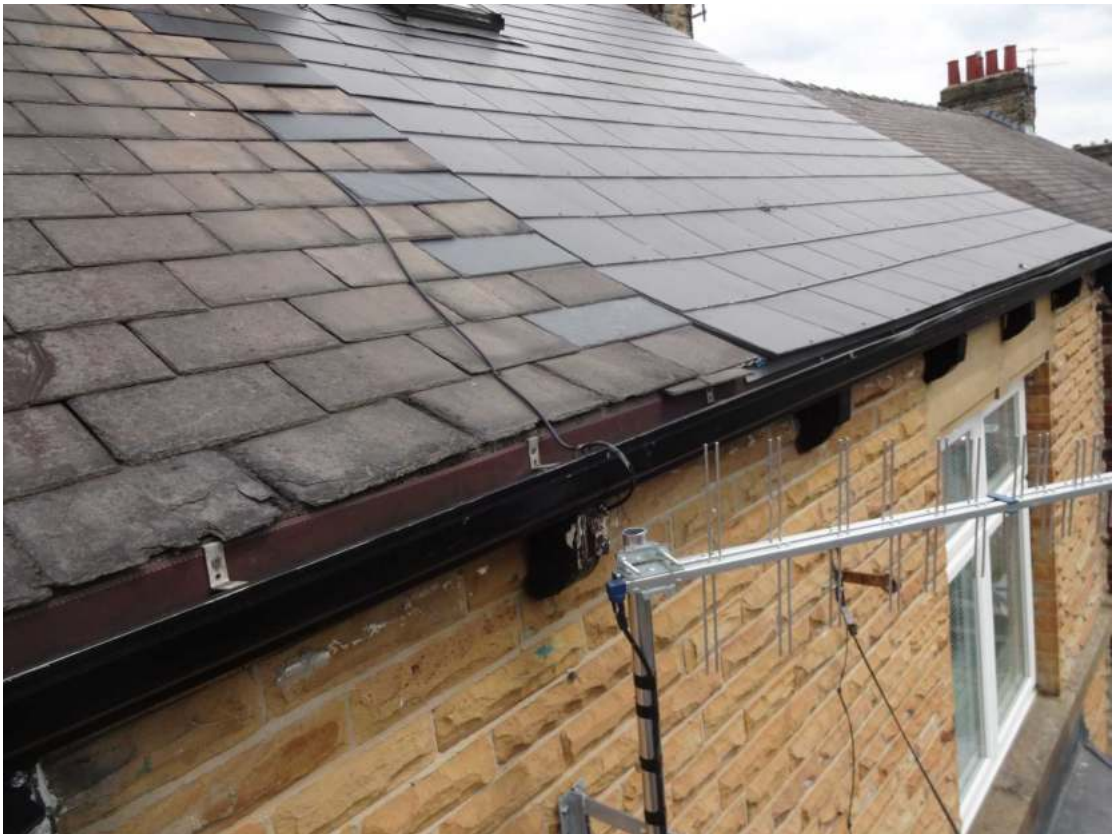
To the front elevation it is obvious that the roofs do not benefit from eave trays to direct any rainwater into the centre of the gutter, this could be causing water to run down the front face of the brickwork/stonework causing possible future damage to the masonry. The condition of the gutters is mostly acceptable and no major issues were indicated during our survey.

Slates short of gutter, fix eaves tray

Action: Consider fitting eaves trays to the front elevation to direct the water into the centre of the gutter, however this can be relatively difficult with the existing roof coverings in place and maybe something to consider with the benefits of a new roof covering.

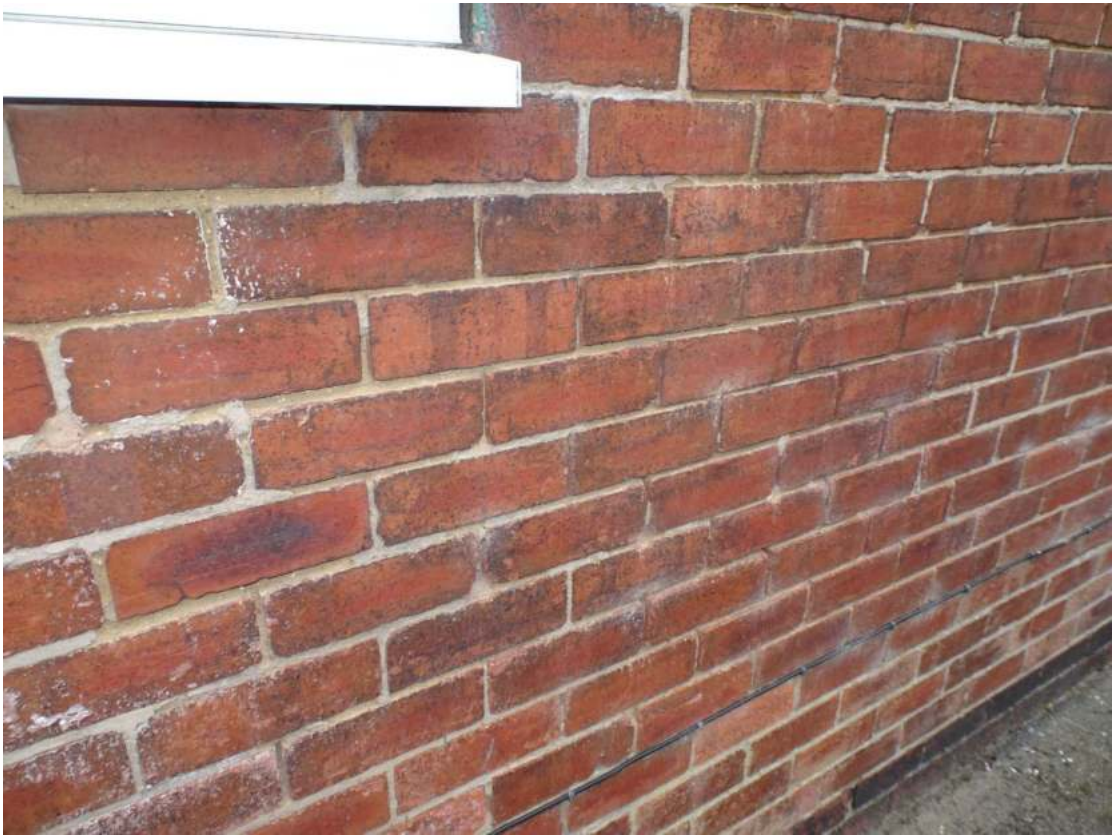
The condition of the external walls was found to be structurally acceptable with no major cracking, distress or movement noted during the survey however there are various areas of defective pointing especially to the brickwork side elevation that would benefit from raking out and repointing in the future.

Areas of repointed needed in future

Action: Consider raking out and repointing various areas of brickwork in the future.

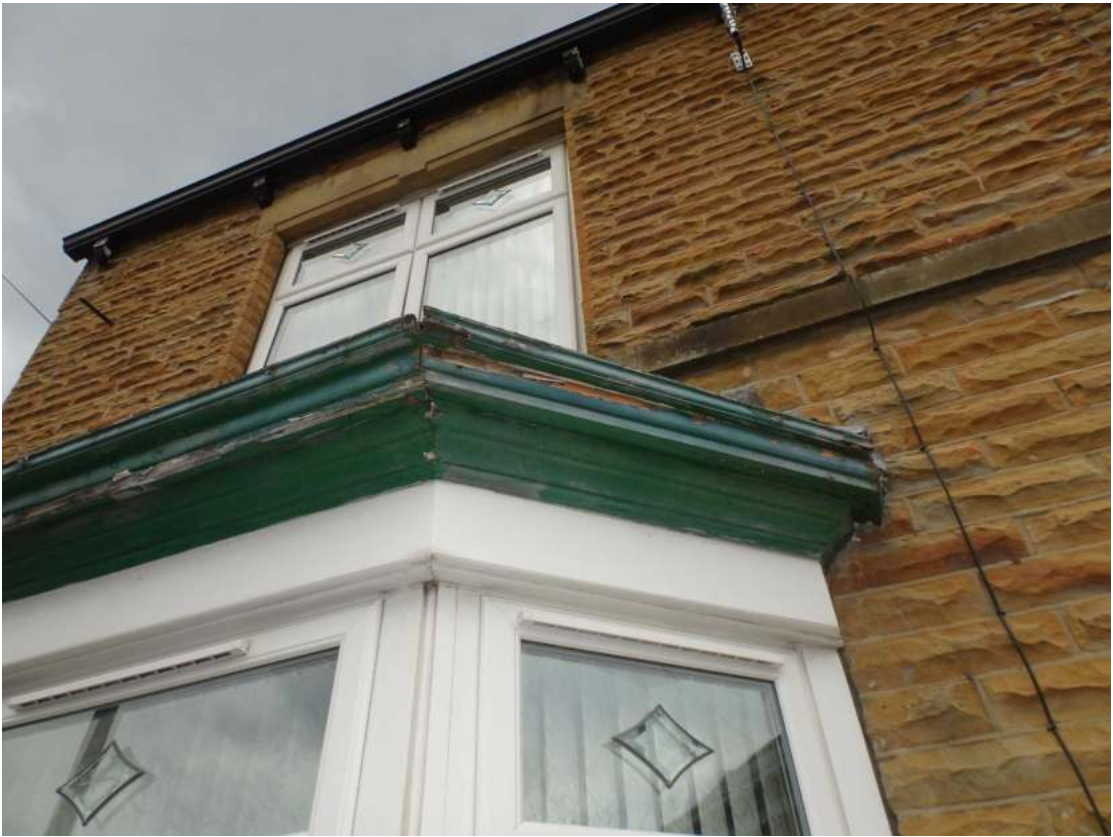
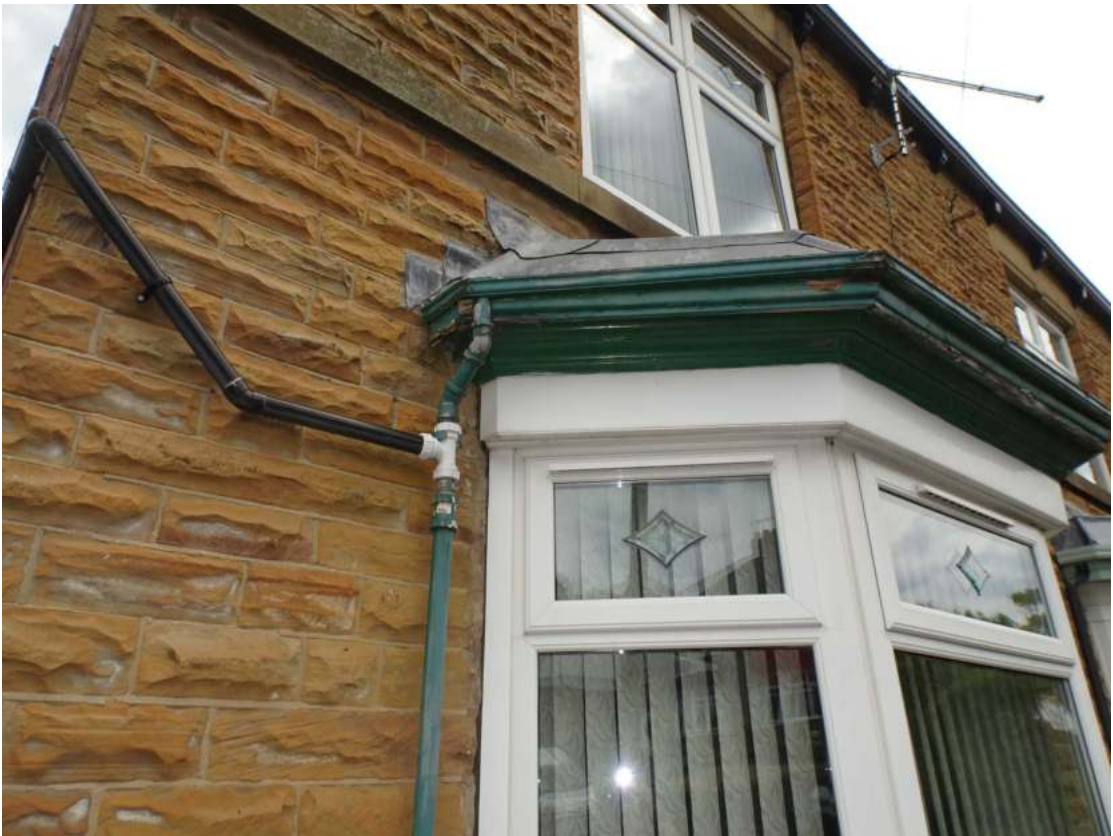
The external timbers are showing signs of deterioration and areas of wet rot and various repairs will be required to the bay window top and the gutter support blocks along with thorough preparation and redecoration of all external timbers.

Action: undertake timber repairs and redecorate all external timbers.

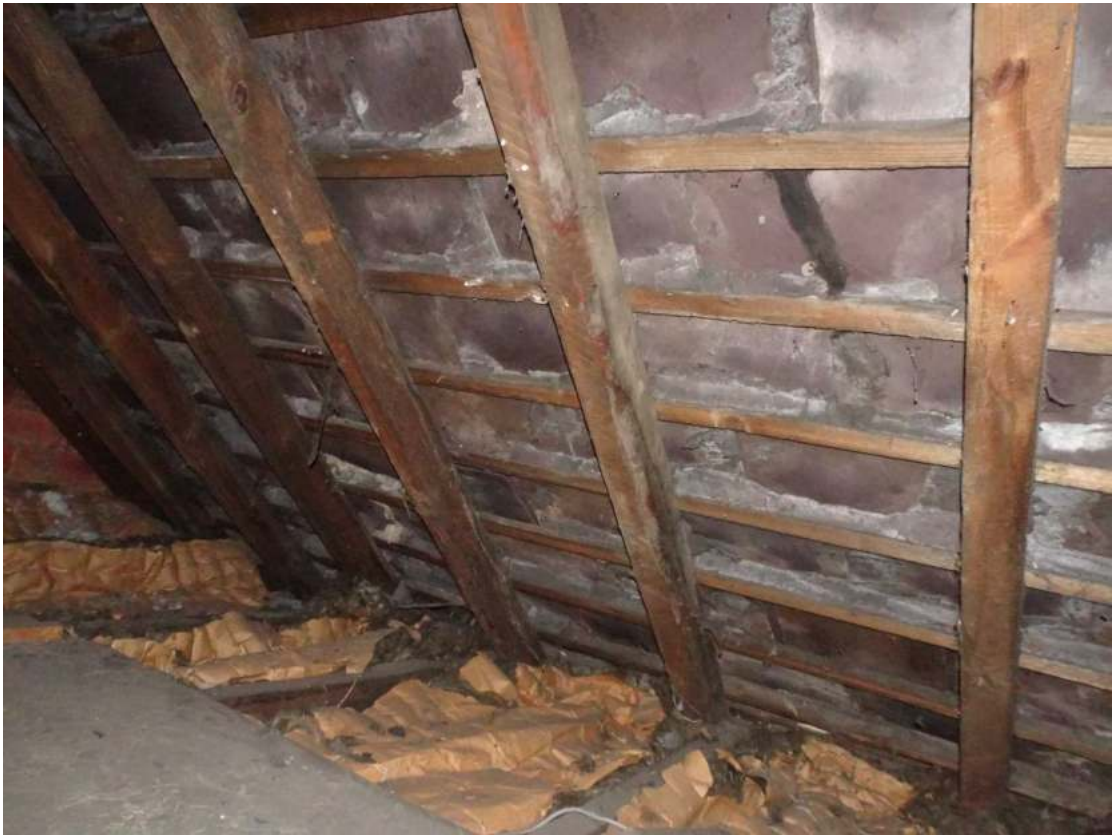
The roof structure itself appears to be in reasonable order with no significant signs of infestation or wood boring beetle were noted. The torching however is crumbling and deteriorating to various areas and this can result in rain penetration especially when the roof coverings are in poor condition as they are here. We would advise keeping the roof covering in the best condition possible to prevent any water ingress to the building.

Torching loose to underside of slates

Action: Budget for the repairs to the roof coverings to prevent water ingress. Consider improving the thermal insulation of the roof and eaves voids.

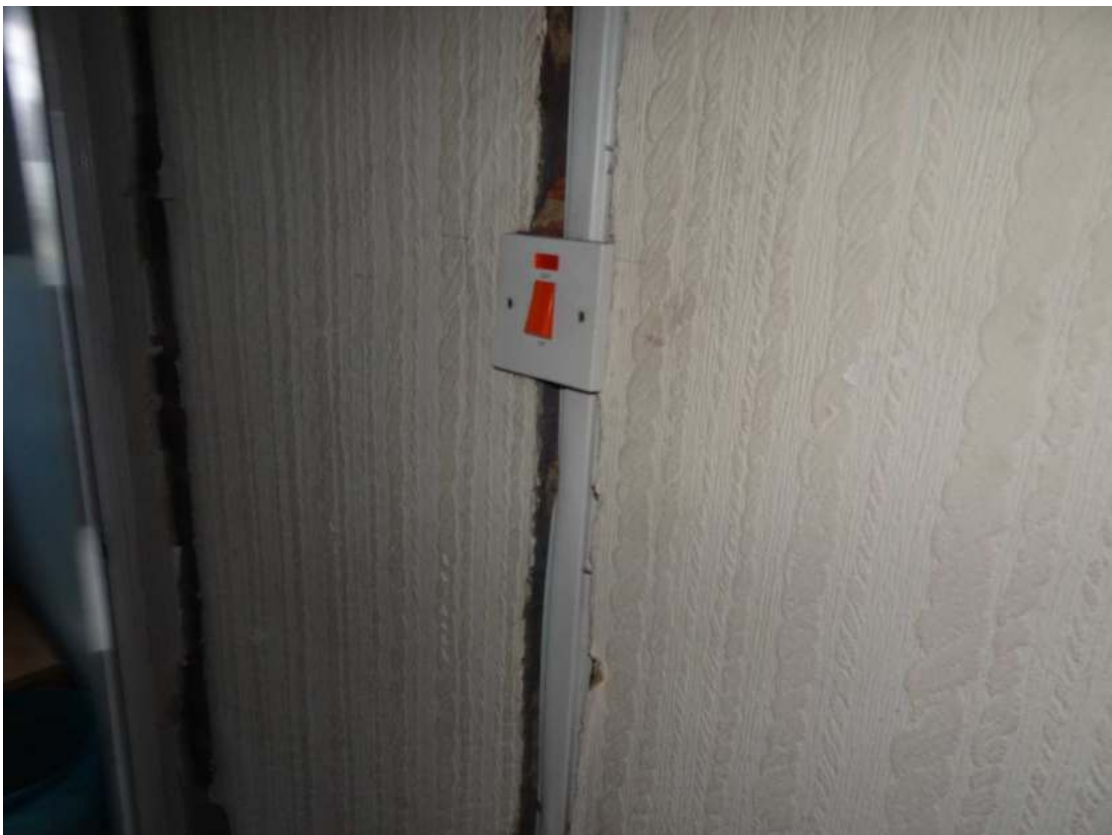
The finishes to the internal walls appeared to be in need of some repairs especially where the vendor appears to have had electrical re-wiring undertaken and the plasterwork still requires making good. There are also some areas of loose and hollow plaster when tested therefore budget for general plaster repairs especially if internal refurbishments are planned.

Plaster repairs required

Action; Budget for plaster repairs to areas of electrical wiring but also areas of loose plaster to other areas.

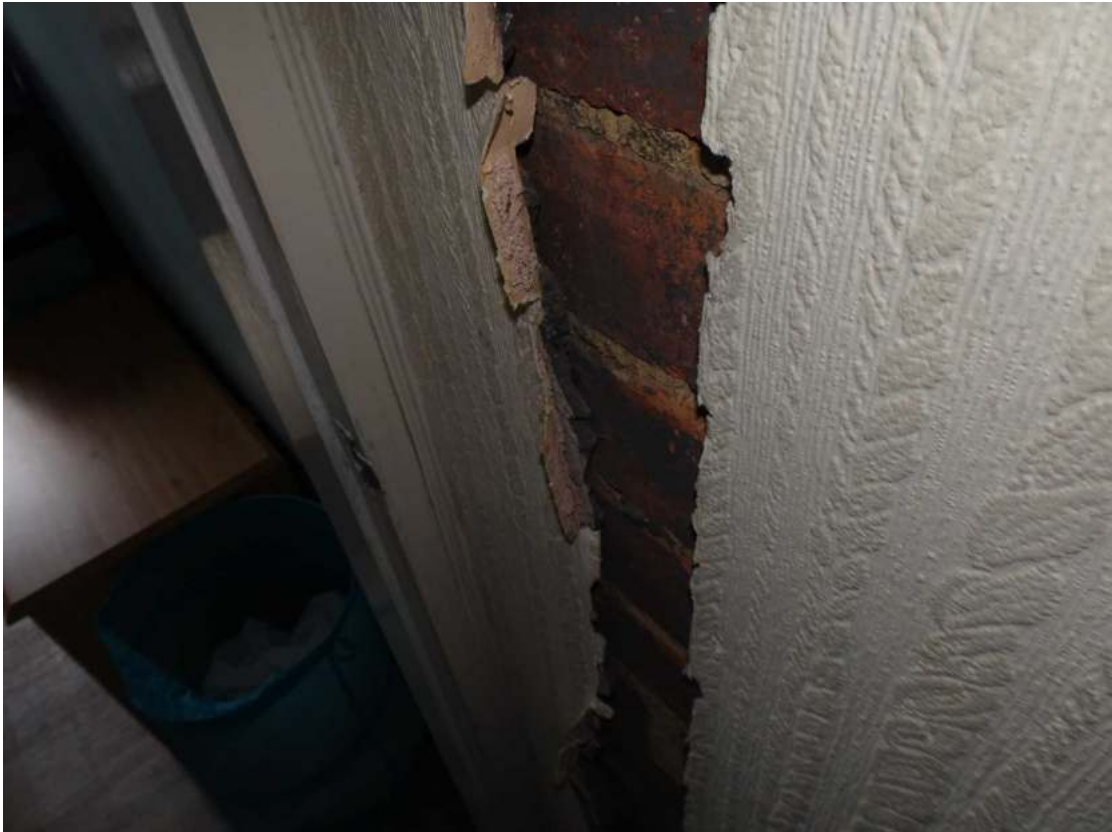
Some areas of loose plaster

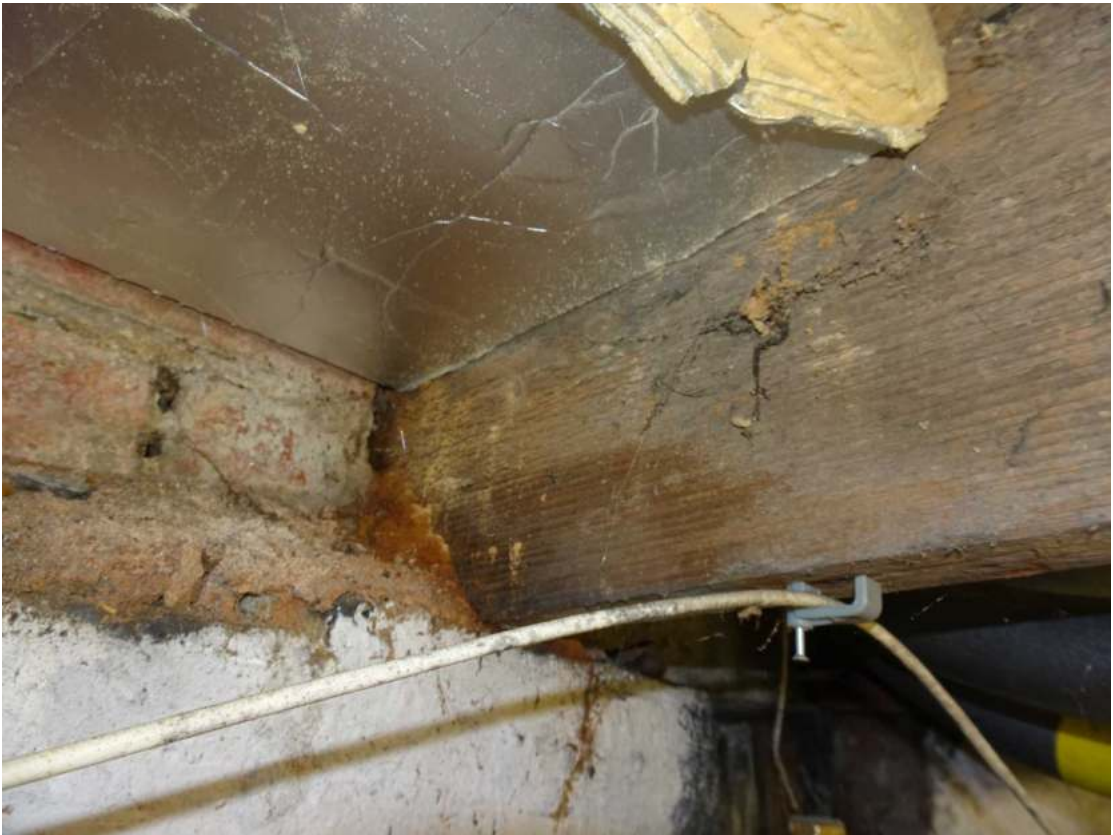
From inspection of the ground floor structure from within the basement signs of wood boring beetle can be seen which will require treatment.

Signs of woodworm

Action: Budget for treating the ground floors and re-fixing the loose floorboards.

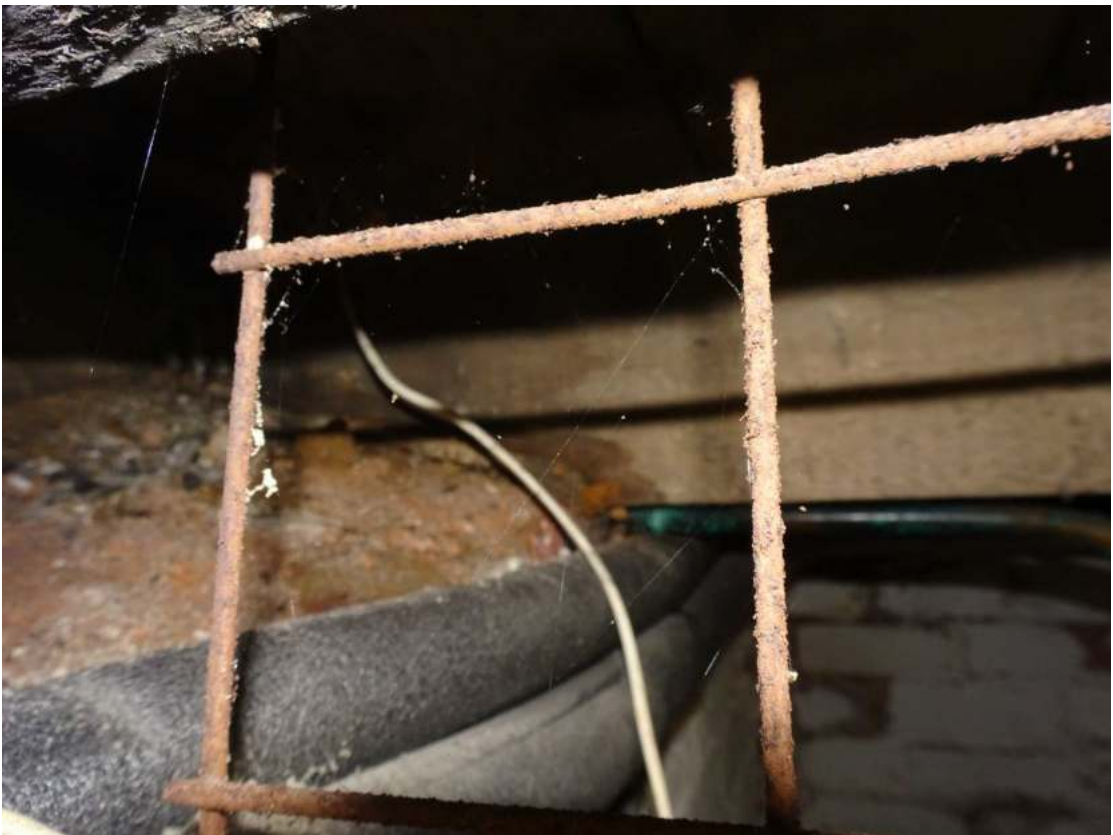
Signs of woodworm

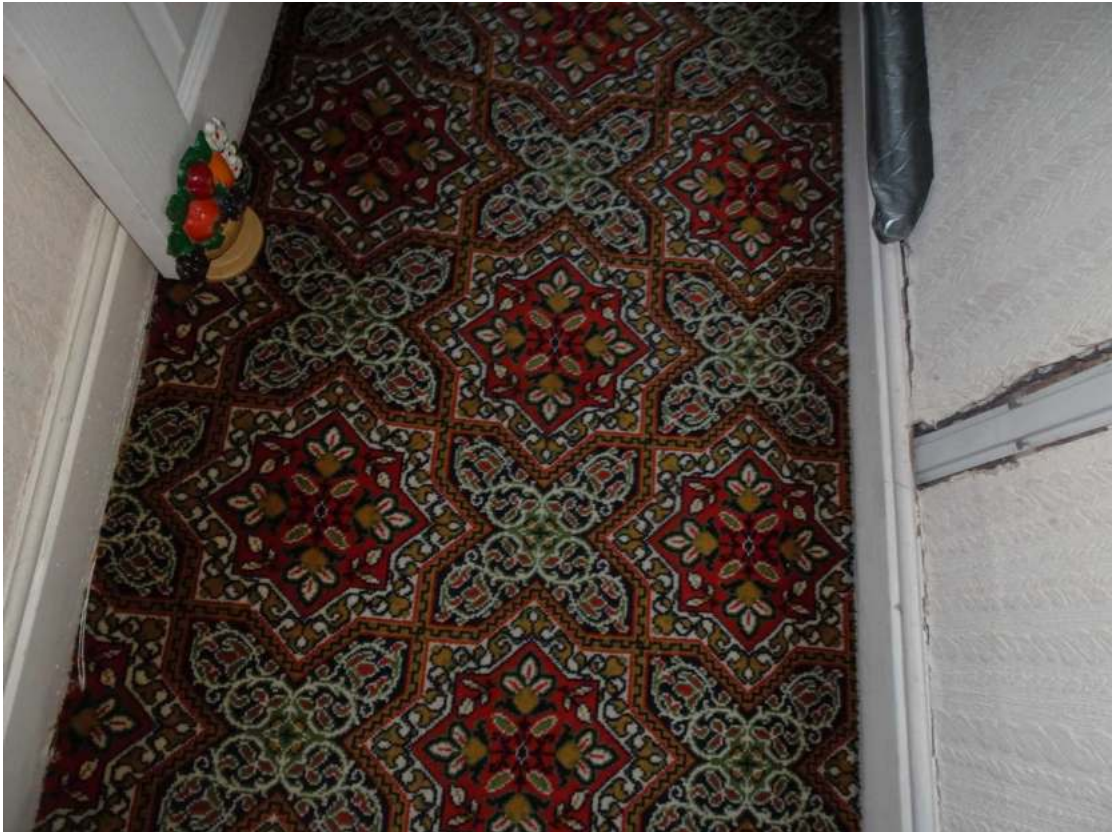
The floors to the property are formed by suspended timber to ground, first and second floor levels, these appeared to be reasonably strong and capable of withstanding domestic loads, there are a small number of loose and creaking floorboards in various areas especially to the first floor that will require re-fixing when carpets are lifted.

Loose floorboards

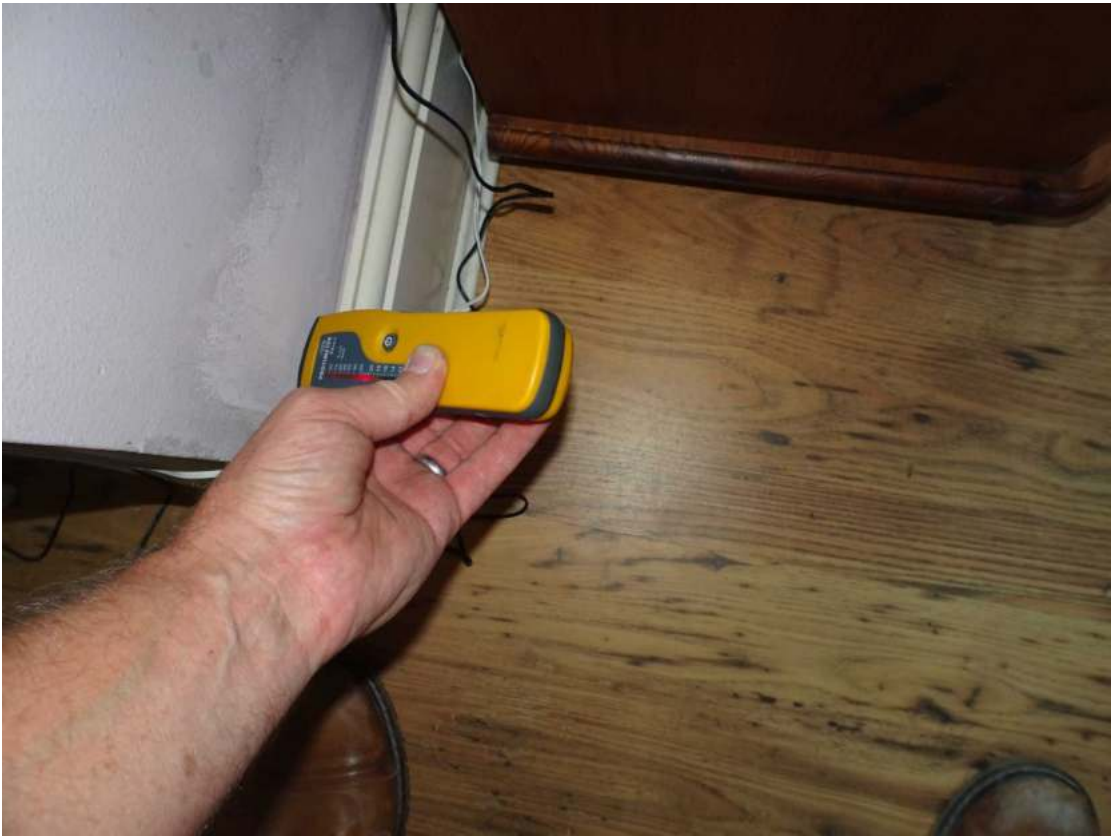
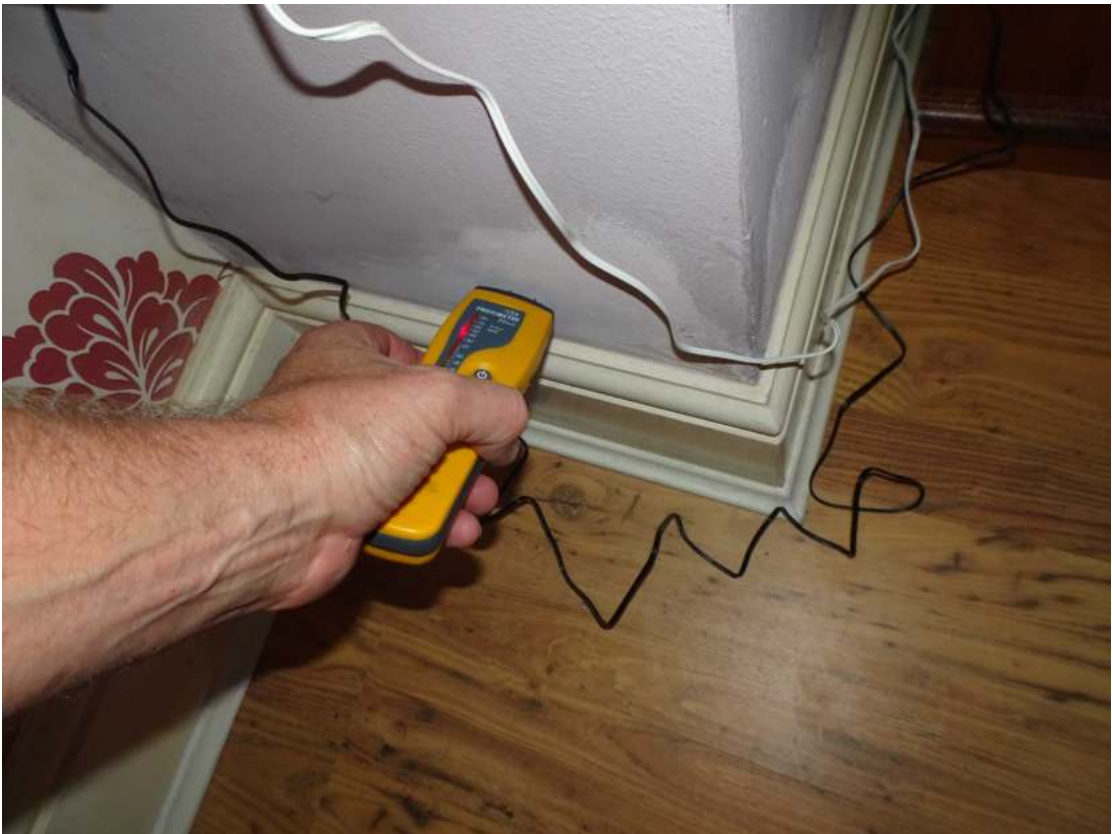
The condition of the chimneys is reasonable, they appear to be structurally sound with no major defects. As they are disused we would advise having a vent fitted at low level to prevent condensation.

Dampness was also noted to the base of the dining room chimney, this can be due to salt contamination from the previous use as a solid fuel fire and should be addressed by the damp and timber contractor at the same time as the ground floor walls.

Action: Consider installing vents, damp and timber contractor to price for removal/treatment of dampness.

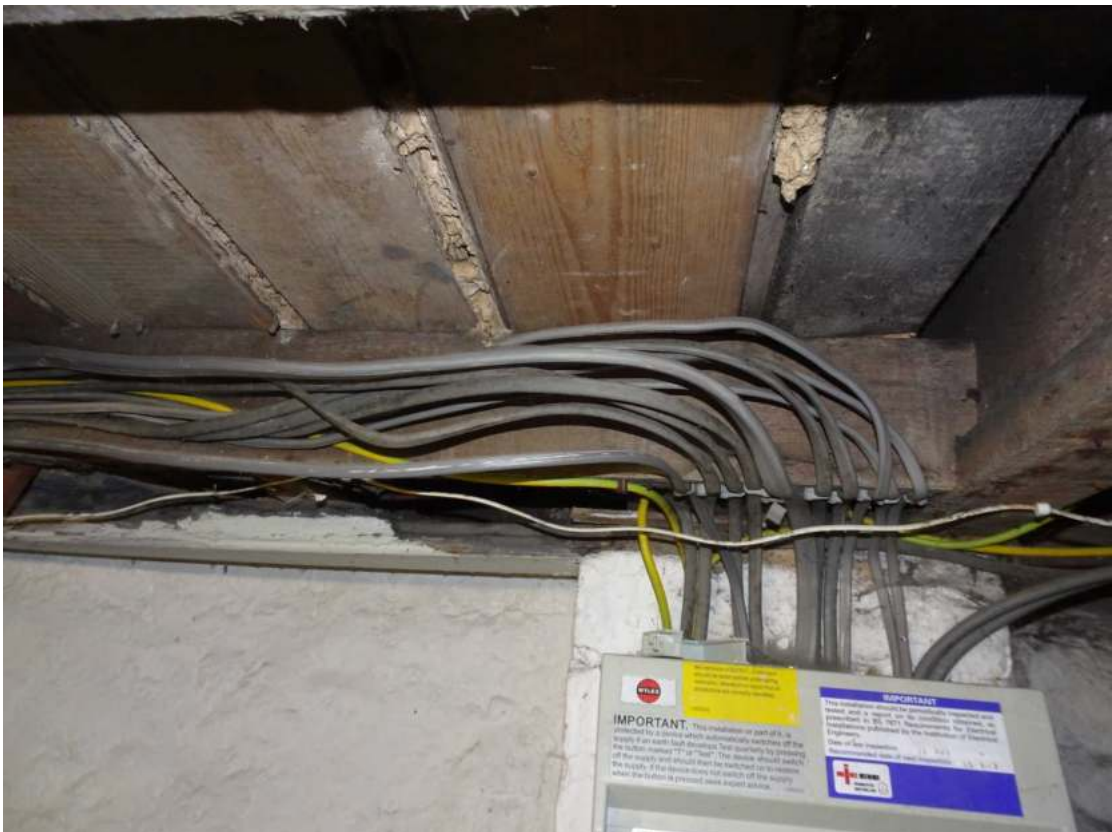
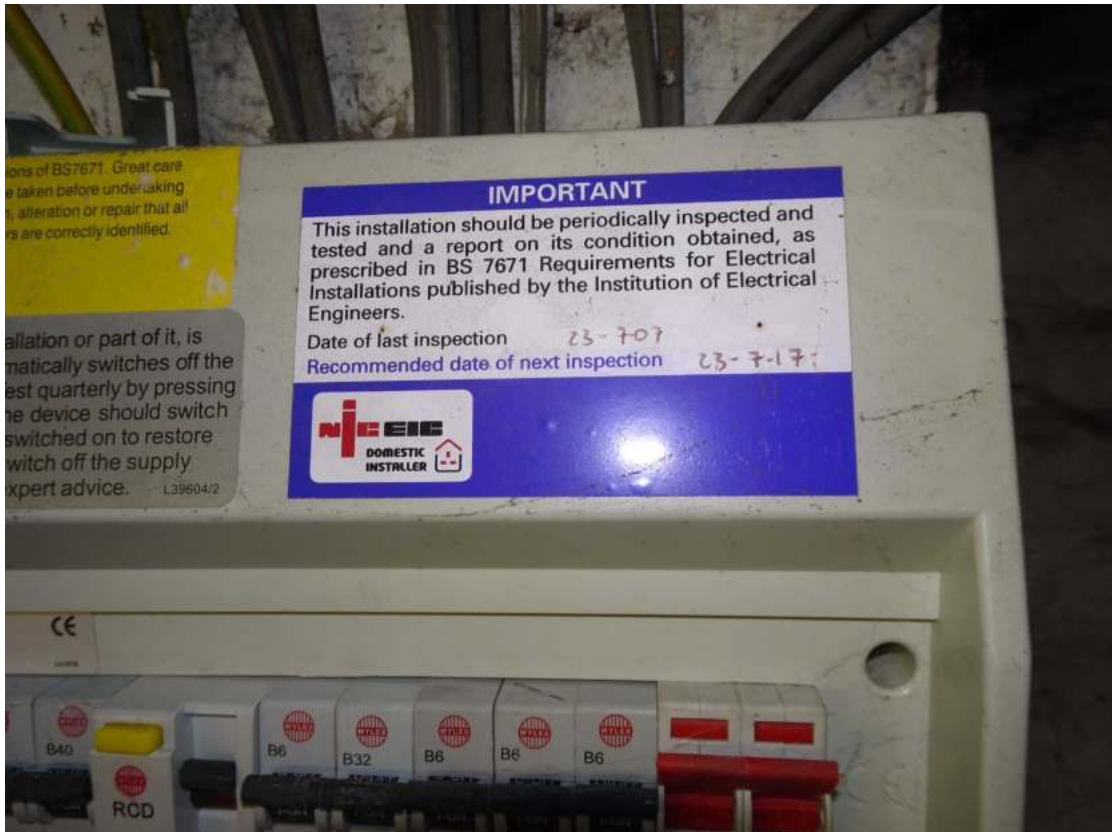
Whilst in reasonable order the electrical system appears to require testing, we would advise having this tested prior to occupation.

Action: Have the electrical system fix wire tested.
