LEVEL 2

Your survey report

84 Airedale Road, Sheffield, South Yorkshire,
United Kingdom, S6 4AW

15/06/2022

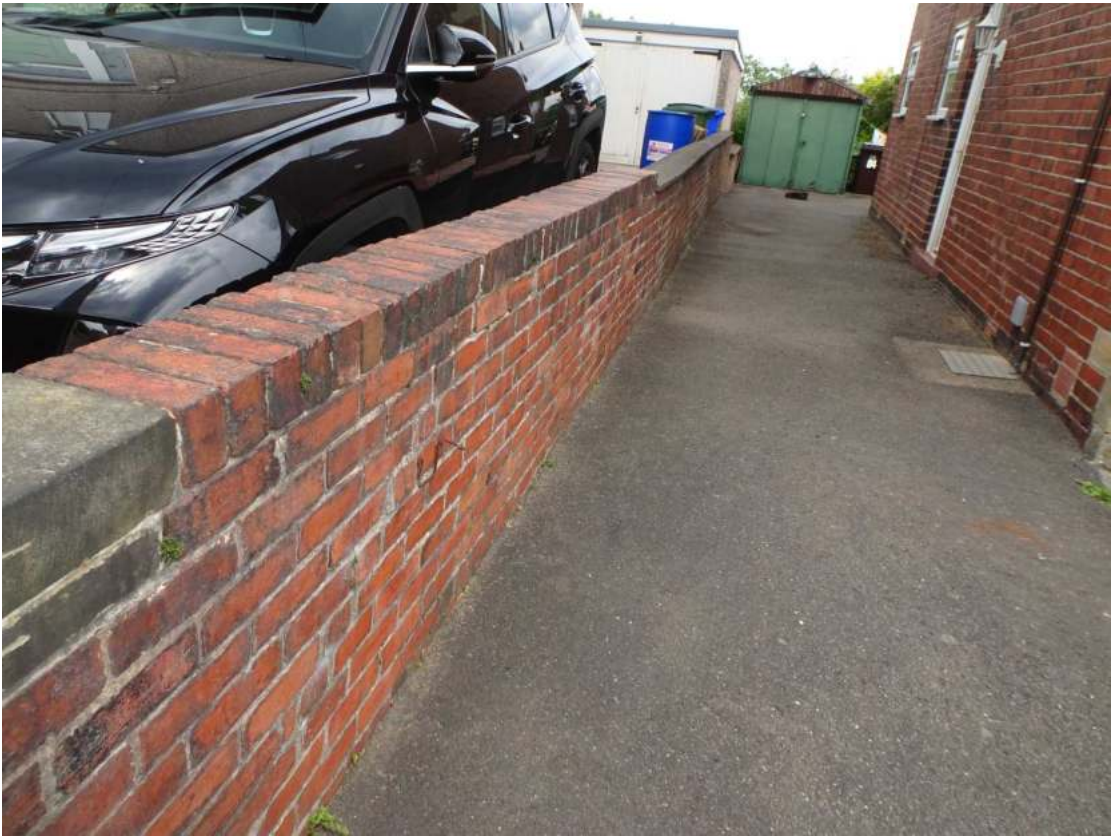
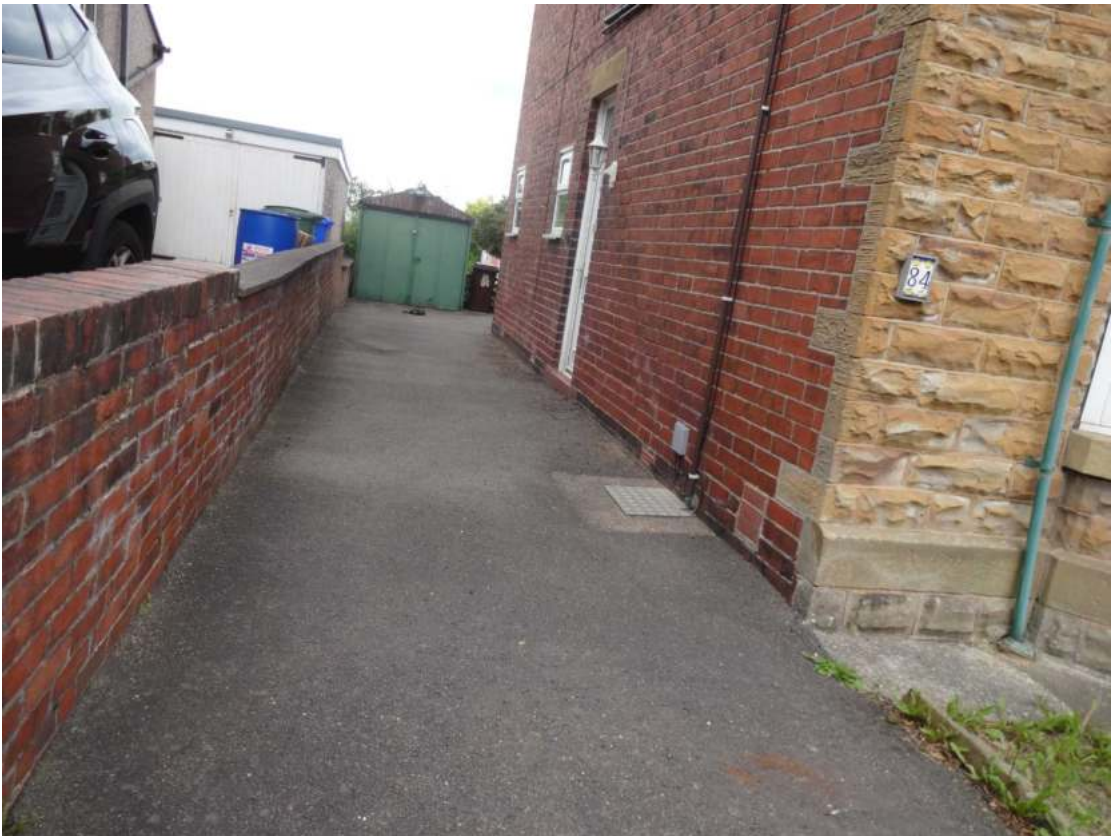
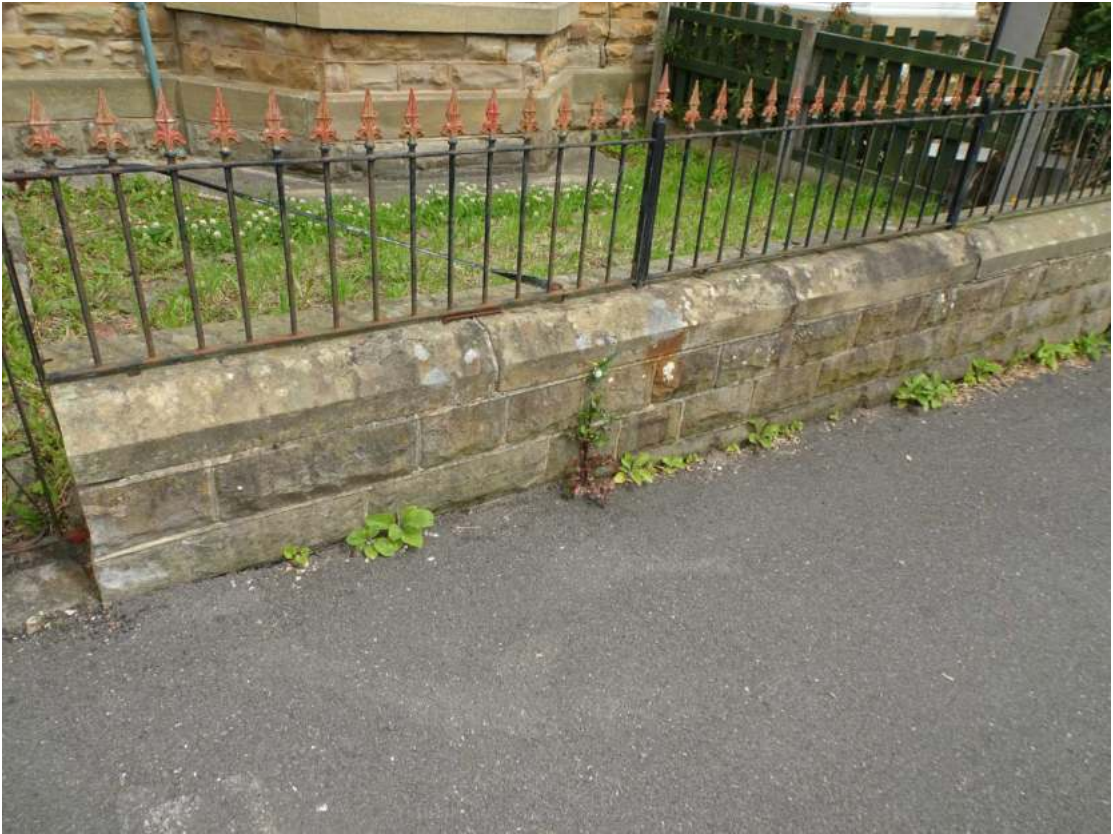
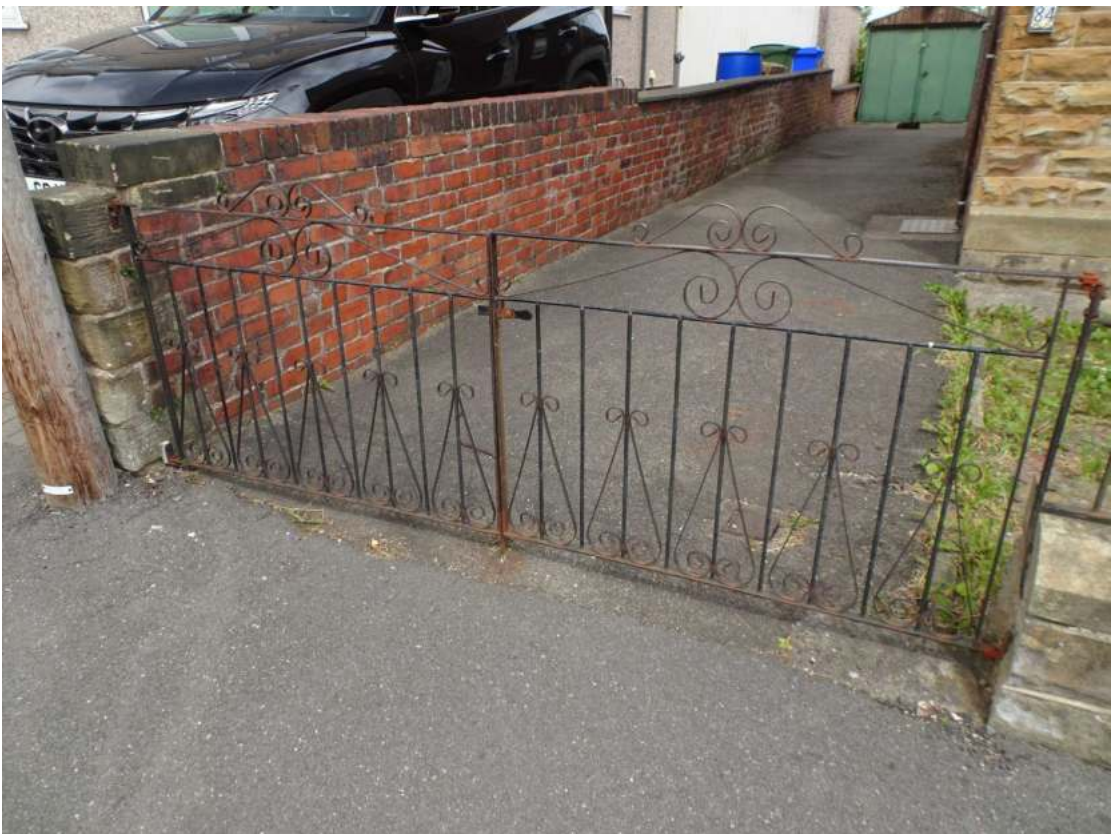
The left hand side boundary is a brick built boundary retaining wall, this is distorted and bowing in places and may require repairs and rebuilding in the future. You should carefully check as to the liability for maintaining this wall as some repairs are very likely to be necessary in the coming years .

To the front boundary is a stone wall with painted railings and metal painted gates. The wall appeared to be in reasonable condition although some minor repointing may be required in the future, the railings require some general repairs and painting more urgently.

To the rear boundaries there are timber fences, these are in fairly poor condition and require various repairs and possible renewal, your legal adviser should carefully advise you on the repairing liabilities for the various boundaries.

Action: Check boundary liabilities, repair to the fences, repair to the gates and railings and check repairing liability for left hand wall.
